MISCELLANEOUS PAPER S-69-27

# LANDING MAT OVERLAY ON DETERIORATED PAVEMENT

## BARE BASE SUPPORT

U. S. Army Engineer Waterways Experiment Station  
CORPS OF ENGINEERS  
Vicksburg, Mississippi

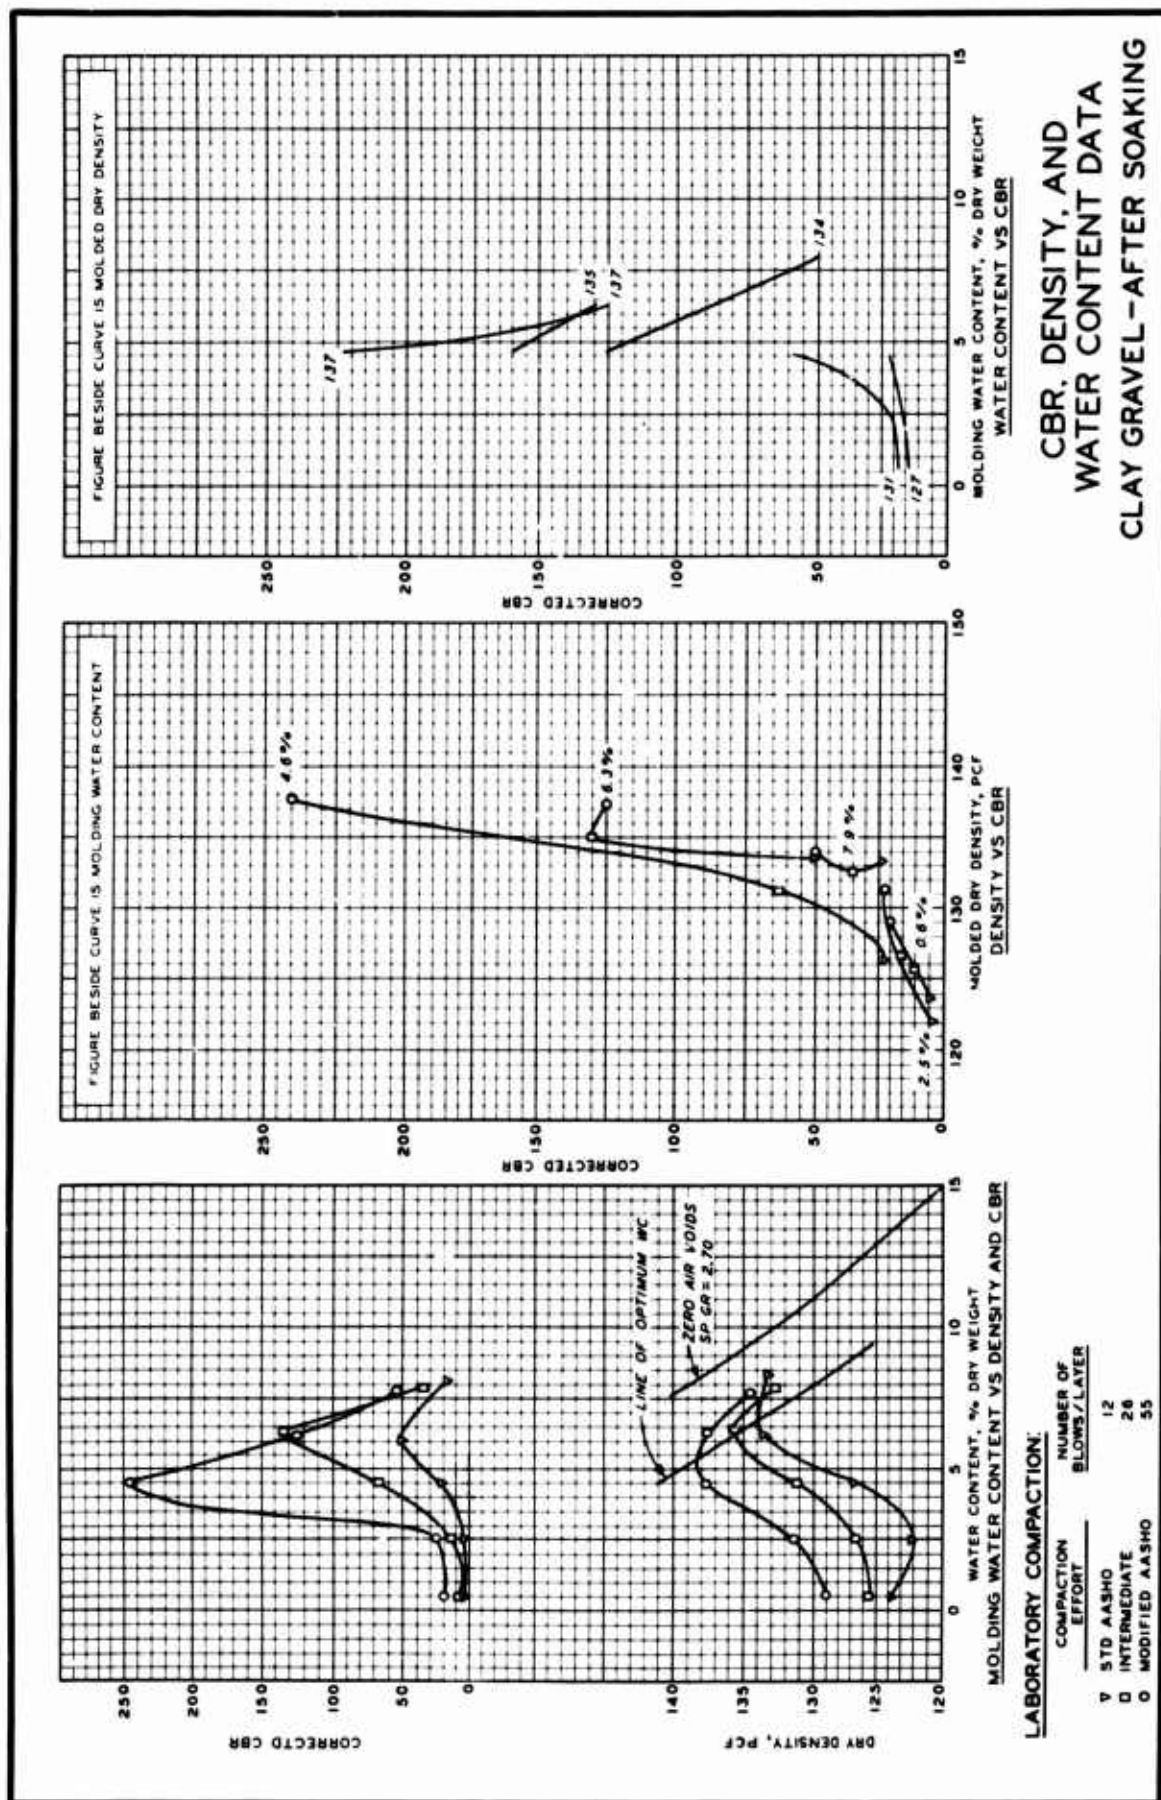
PLATE 4

8. Laboratory compaction and CBR data for the clay gravel are shown in plates 3 and 4. The data in plate 3 are for the as-molded condition, and the CBR values in plate 4 were obtained on soaked specimens.

17. It was expected that the sand in items 1 and 2 would be somewhat confined under the landing mat and would, therefore, remain relatively stable. An examination of the laboratory CBR curves for the clay gravel (plates 3 and 4) indicated that if the clay gravel was compacted at a water content of 3.5 to 4.5 percent using a field compaction effort about equal to the lowest laboratory effort shown, a soil strength in the range of 45 to 55 CBR could be obtained. The soaked CBR data (plate 4) indicated that if this soil was then subjected to soaking, an acceptable strength loss to the range of 10 to 20 CBR would result. Therefore, it was decided to place the clay gravel in items 3 and 4 at a water content of 3.5 to 4.5 percent, since if the soil became soaked during rainy weather, the resulting strength loss would not be particularly detrimental to the performance of the overlay cushion.
